COMPREHENSIVE MOTOR VEHICLE SERVICES & CONSULTING Motor Vehicle Forensic Analysis Report

People of the State of New York v.
Nauman Hussain

REFERENCED INVOLVED SUBJECT VEHICLE: 2001 Ford Excursion Stretch Limousine,
VIN 1FMNU40S51EB10299

MOTOR VEHICLE AUTOPSY FORENSIC INVESTIGATION SUMMARY

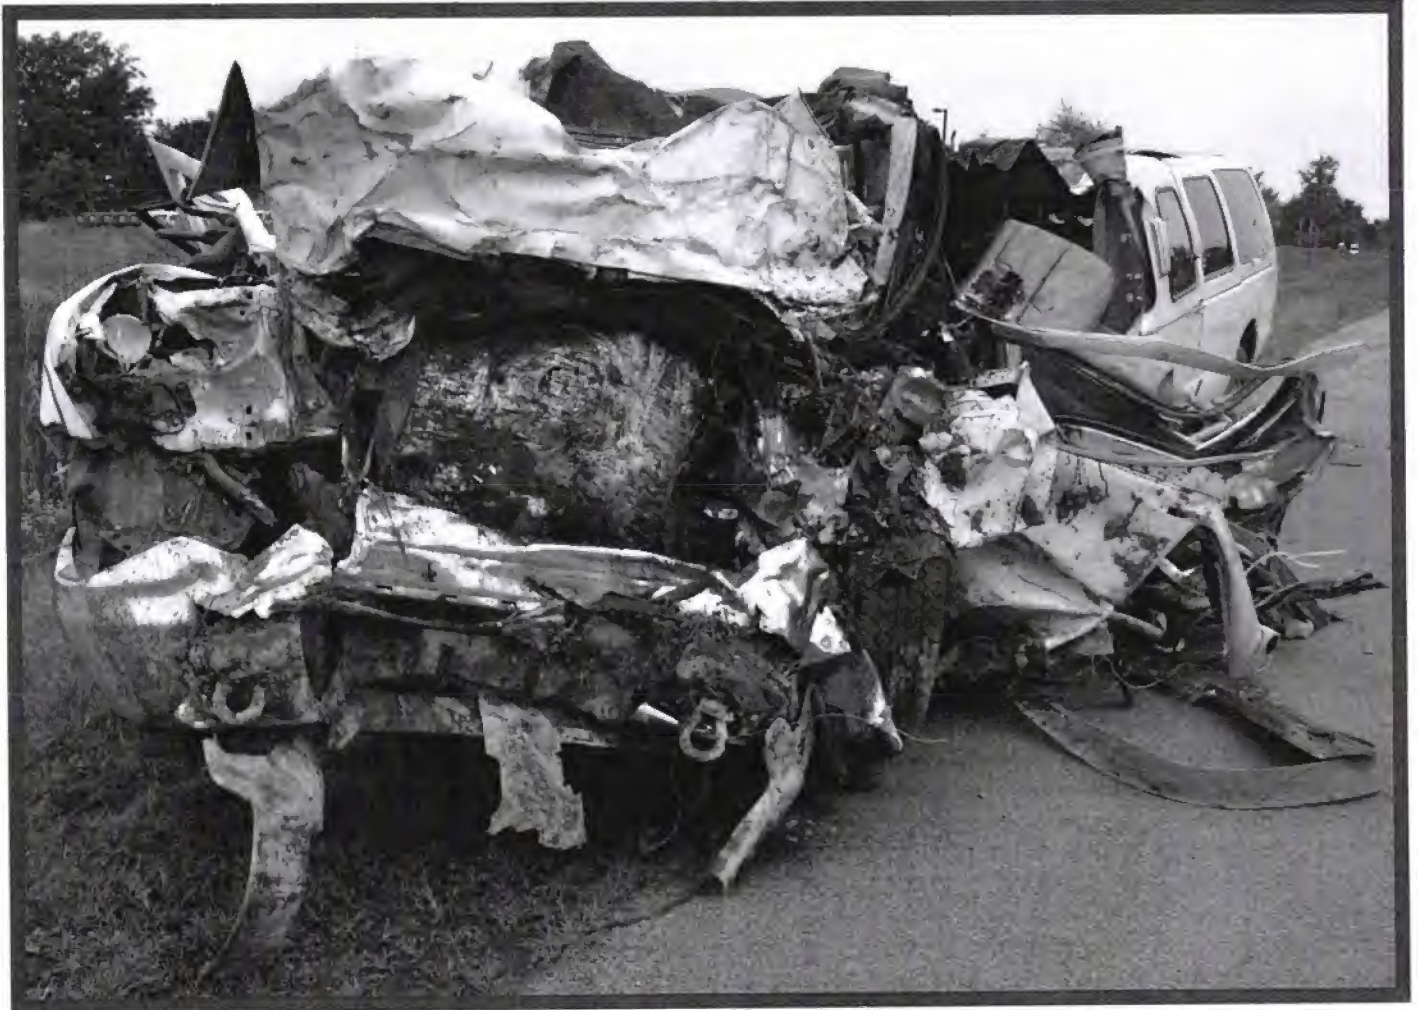
Image No.4. This photograph depicts the severity of the frontal structural damage sustained by the 2001 Ford Excursion stretch limousine due to the violent impact forces of the crash. Note that the structural integrity of the vehicle rearward of the B-Pillar -- that of the area of "stretch" alteration -- remains intact.

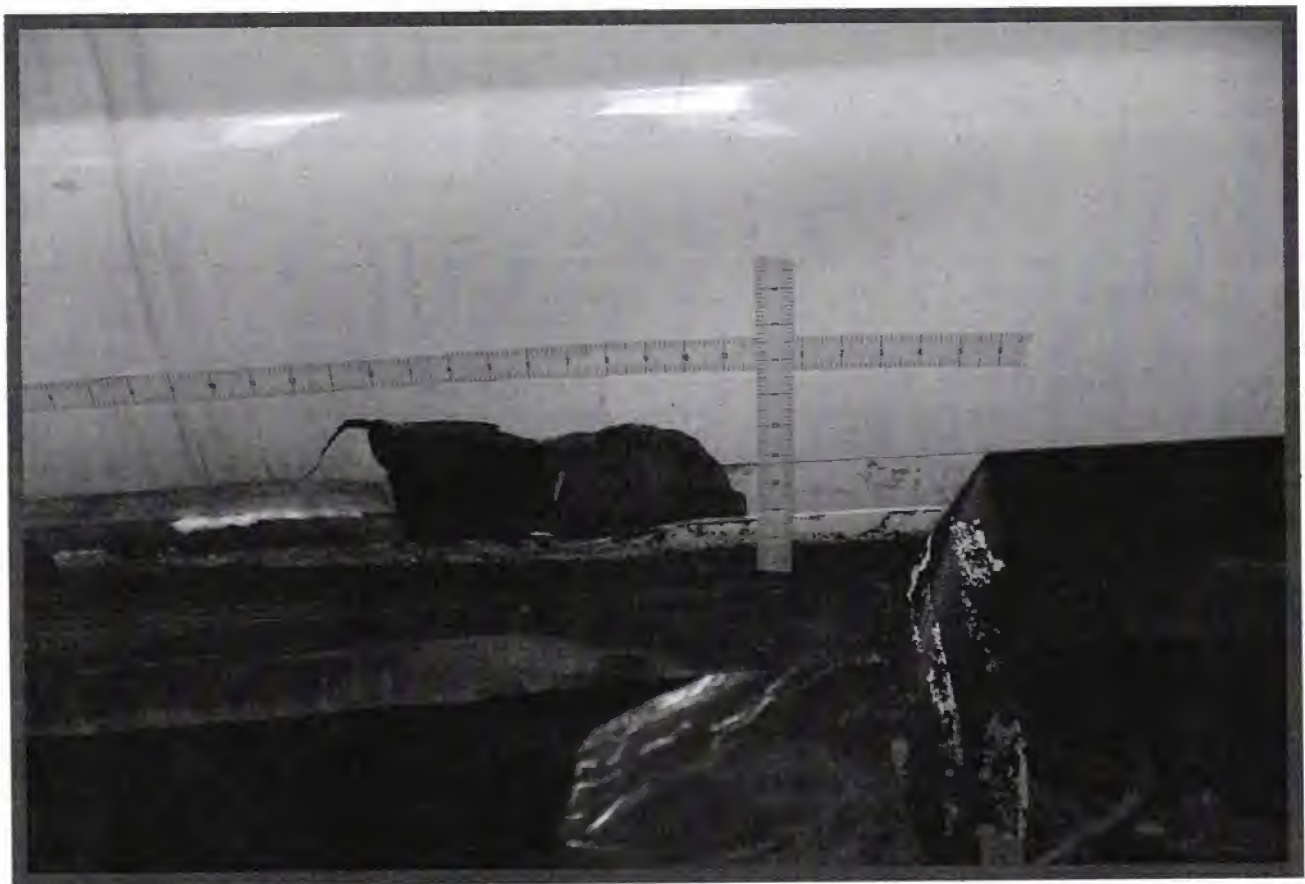
Image No.5. This photograph depicts an area of rust-through, located at the left lower side of the 2001 Ford Excursion stretch limousine. This deficiency, which obviously creates a reduction in the integrity of the body panel, as well as allowing for exhaust gases to enter the passenger compartment of the vehicle, reflects that of sustained neglect of mandated vehicle maintenance.

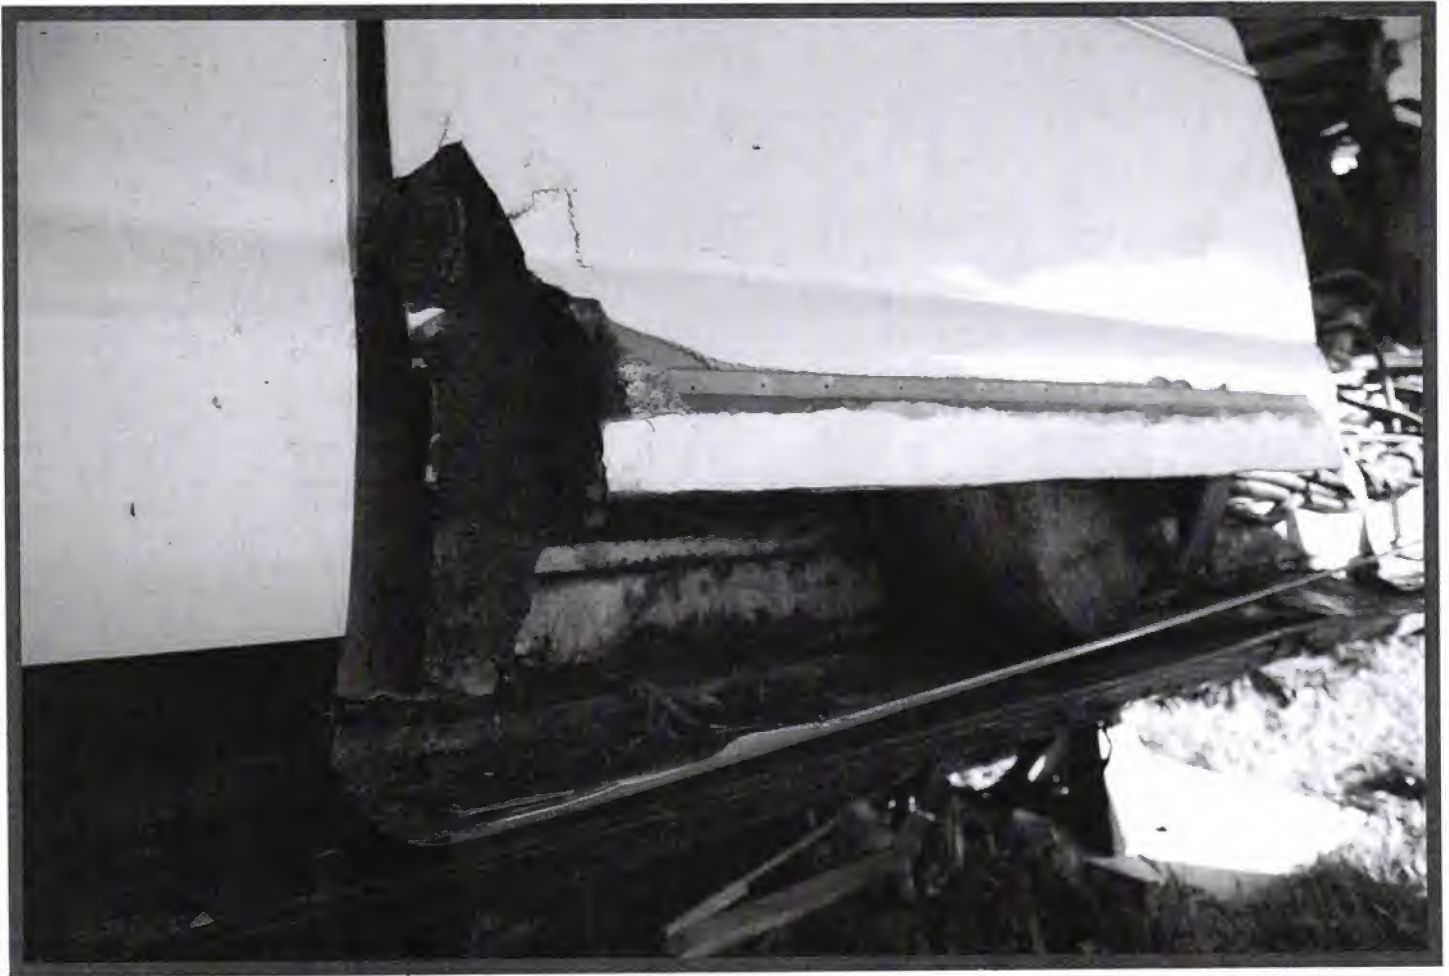
Image No.6. This photograph depicts an area of rust-through, located at the right lower side of the 2001 Ford Excursion stretch limousine. This deficiency, which obviously creates a reduction in the integrity of the body panel, as well as allowing for exhaust gases to enter the passenger compartment of the vehicle, also reflects that of sustained neglect of mandated vehicle maintenance.

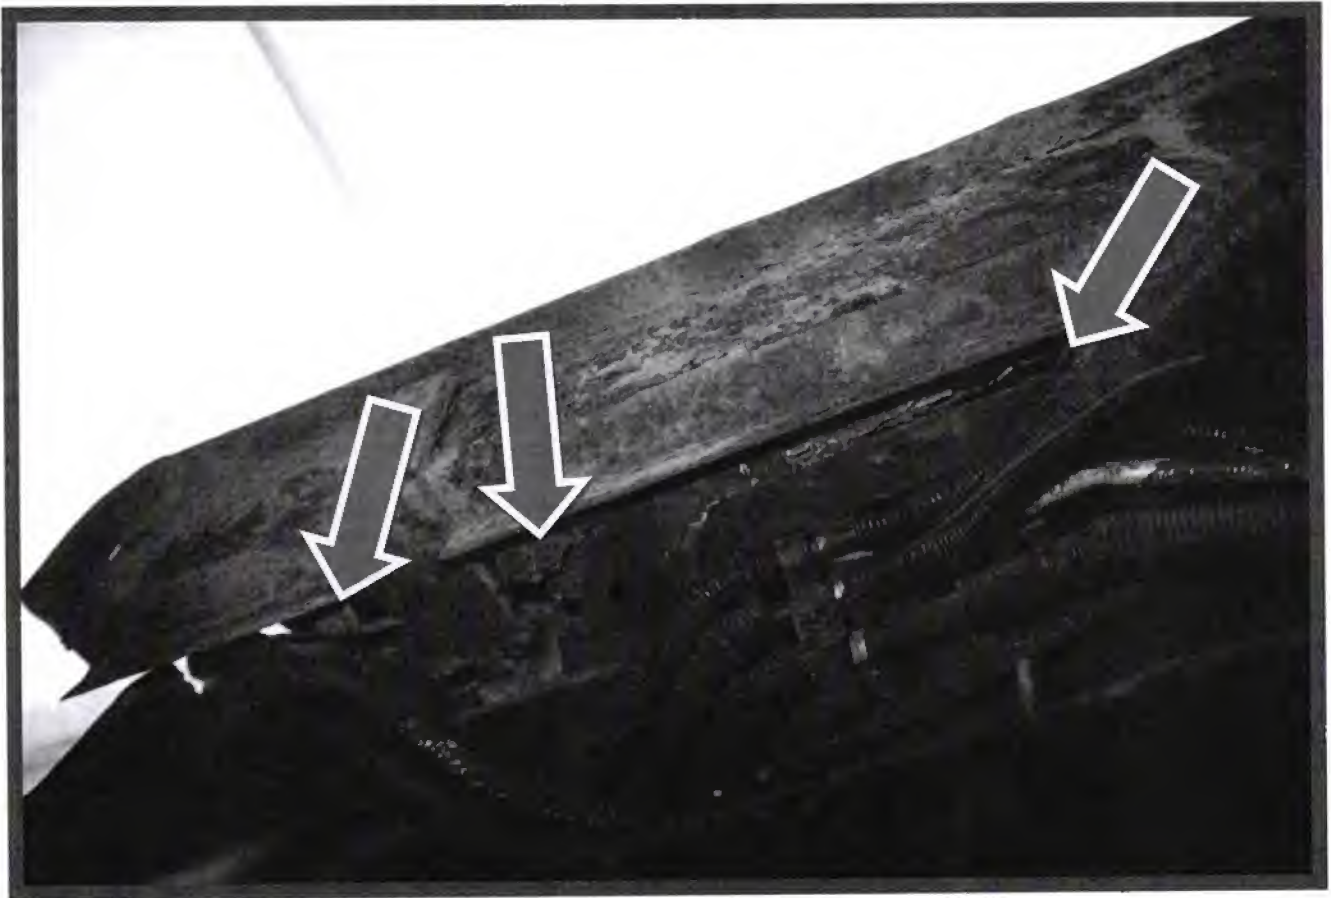
Image No.7. The Red Arrows of this photograph depicts areas of rust-through, located at the right rear floor area of the 2001 Ford Excursion stretch limousine. This deficiency, which obviously creates a reduction in the integrity of the floor panel, as well as allowing for exhaust gases to enter the passenger compartment of the vehicle, further reflects that of sustained neglect of mandated vehicle maintenance.

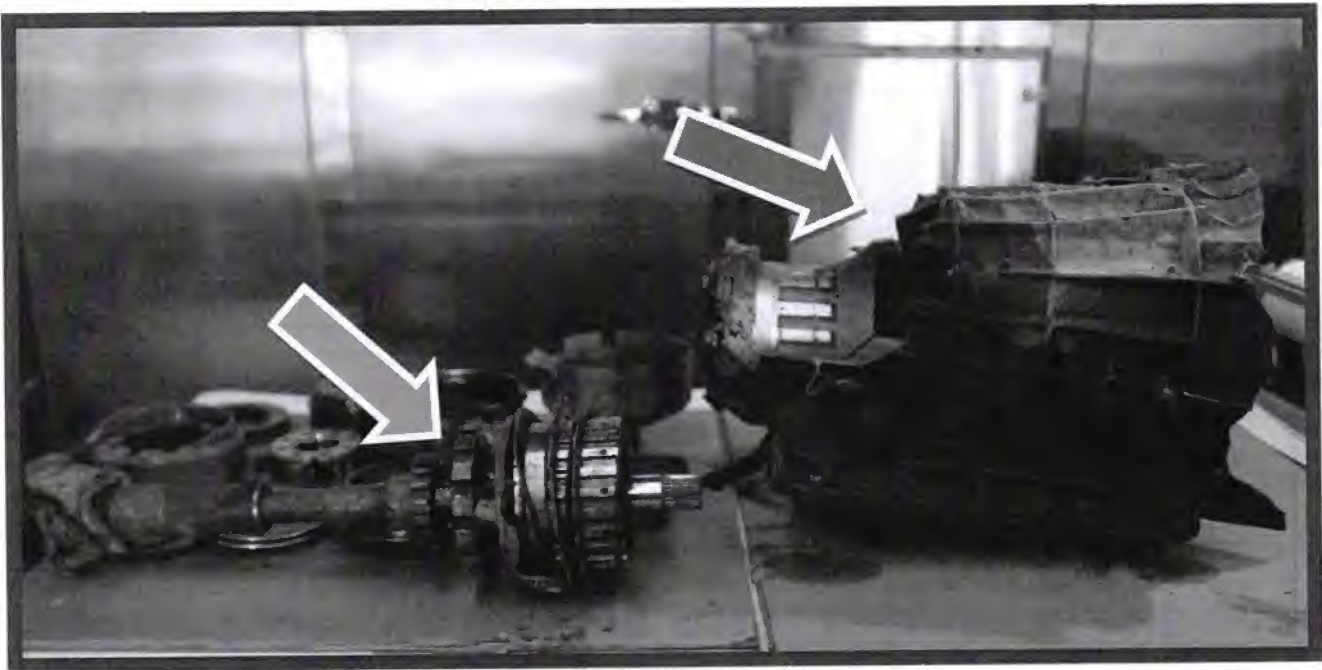
Image No.8. This photograph depicts the E4OD/4R100 automatic transmission removed from the involved 2001 Ford Excursion stretch limousine. The Blue Arrow denotes the area of the fractured transmission Main Case, with related Extension Housing separation, as well as Output Shaft (Green Arrow) separation. This substantial damage was the result of the extreme forces associated with crash impact.

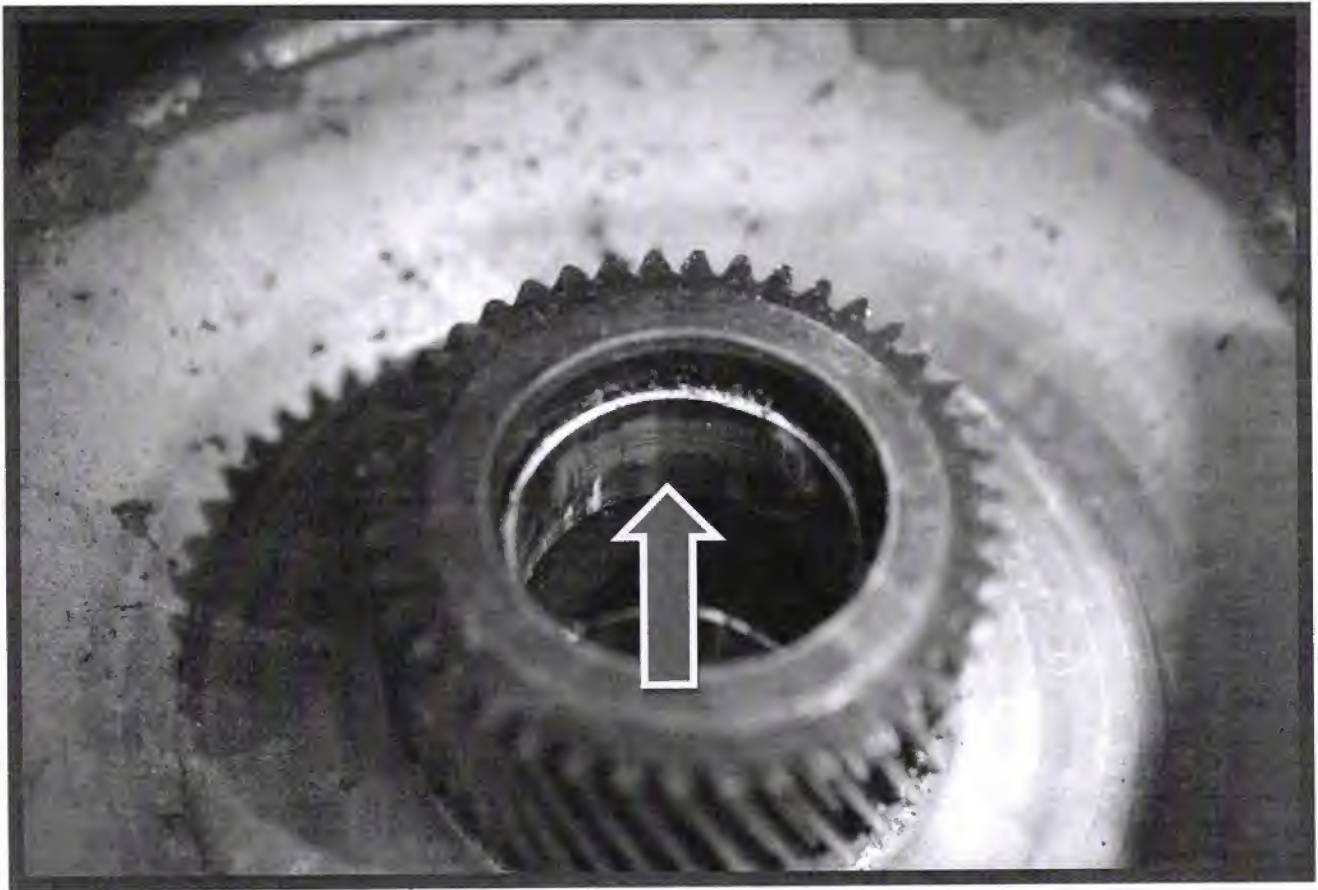
Image No.9. This photograph depicts the Forward/Reverse Sun Gear removed from the E4OD/4R100 automatic transmission of the involved 2001 Ford Excursion stretch limousine. The Red Arrow denotes the area of significant bushing wear, consistent with the lack of proper vehicle maintenance.

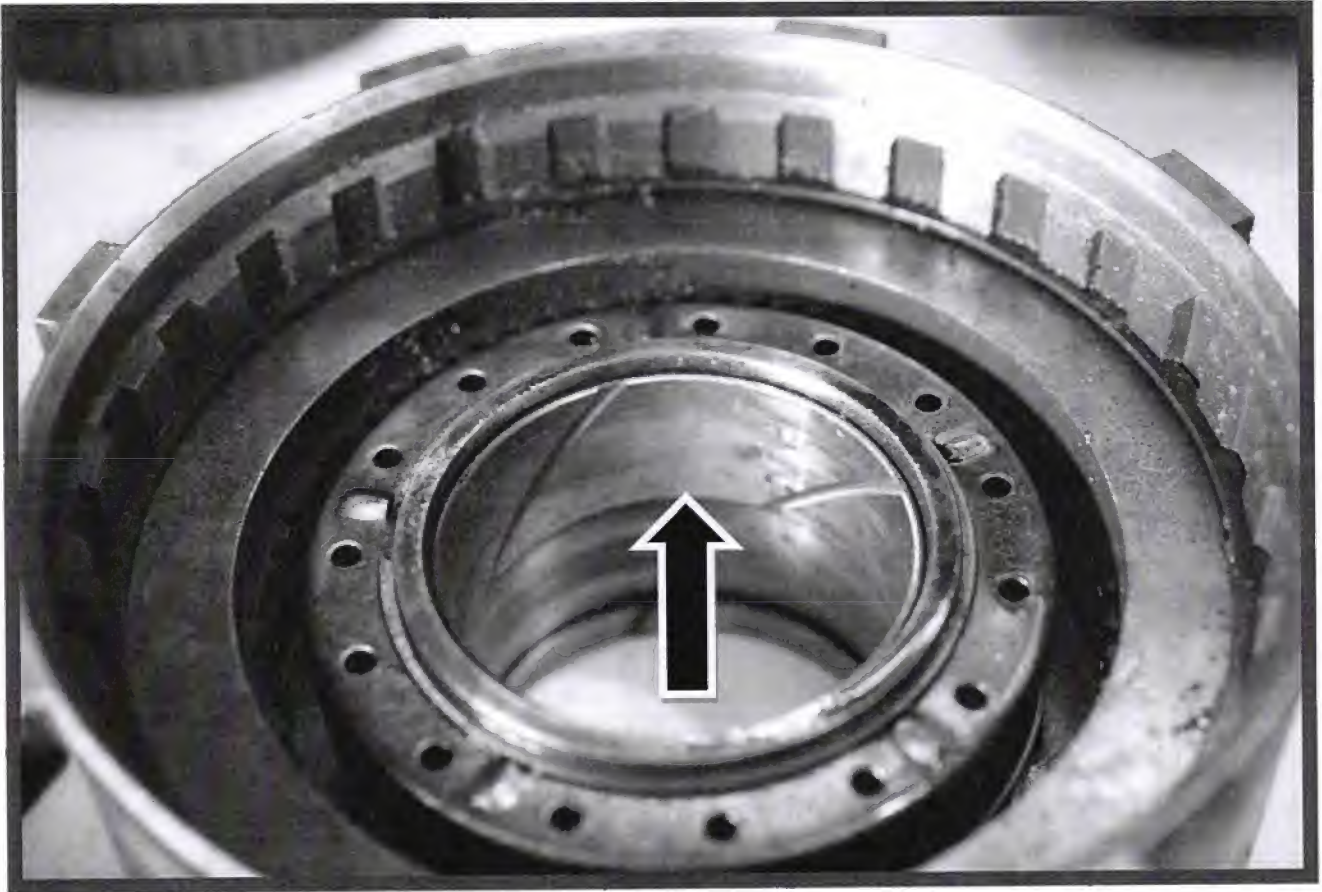
Image No.10. This photograph depicts the Direct Drum removed from the E4OD/4R100 automatic transmission of the involved 2001 Ford Excursion stretch limousine. The Black Arrow denotes the area of significant bushing wear, consistent with the lack of proper vehicle maintenance.

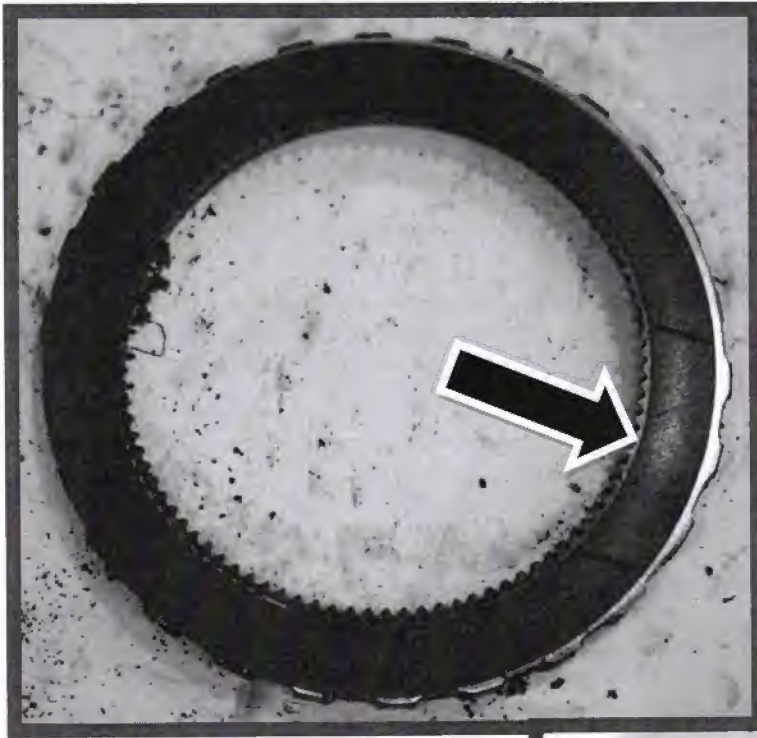
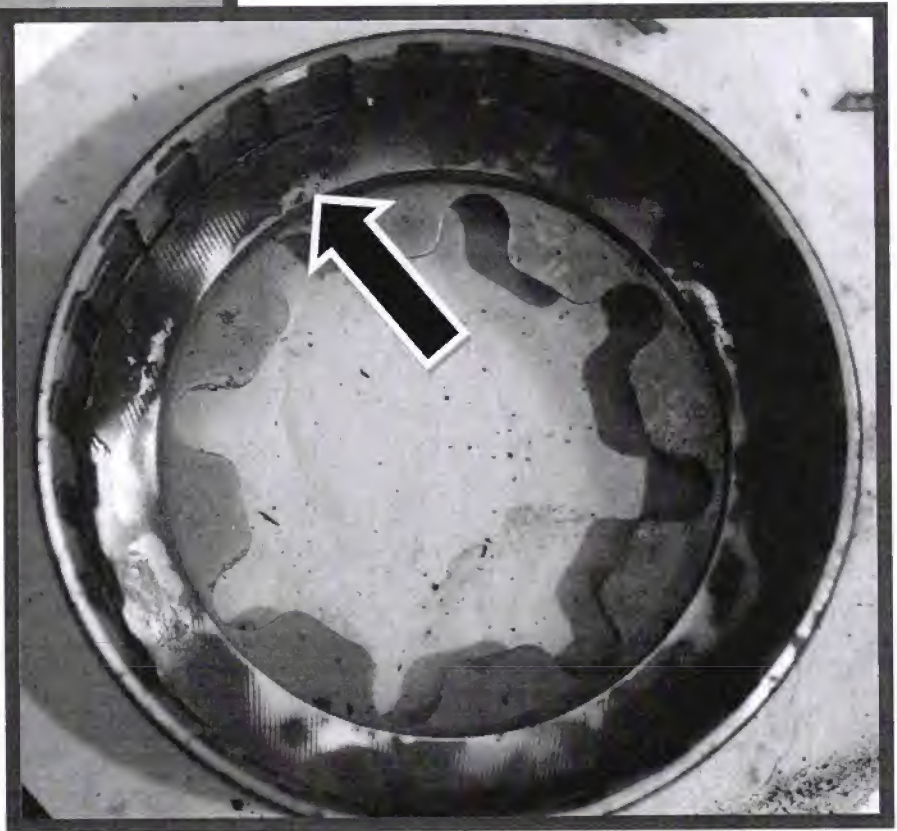
Images No.11a & 11b. These photographs depict two of the Forward Clutch friction discs removed from the E4OD/4R100 automatic transmission of the involved 2001 Ford Excursion stretch limousine. The Black Arrows denote the comparison of common friction material of a friction disc (Top Photo), to that of a friction disc of which the friction material has delaminated and overheated. This condition is consistent with the lack of proper vehicle maintenance.

The disassembly and analyses of the components of the E4OD/4R100 automatic transmission removed from the involved 2001 Ford Excursion stretch limousine revealed evidence of the lack of proper maintenance to the concerning degree of notable transmission slippage when accelerating the vehicle from a stopped position. This condition would have been obvious to anyone who drove the vehicle, or experienced the vehicle accelerating from a stop.

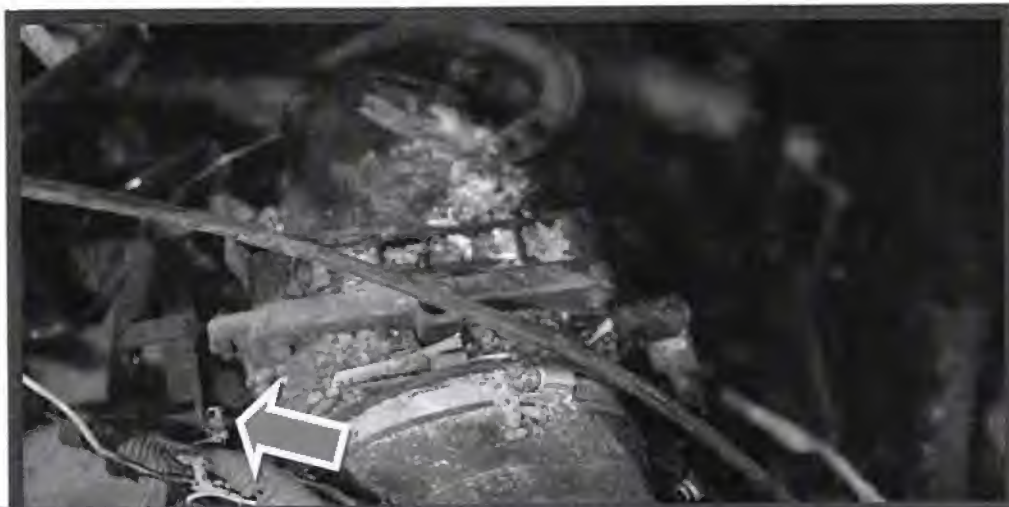
Image No.12. This photograph depicts the Throttle Body of the involved 2001 Ford Excursion stretch limousine prior to removal for examination. The Blue Arrow denotes the Throttle Plate linkage, which is at a position of partially opened Throttle Plates. This was the direct result of the violent impact forces, which resulted in notable structural frame deformation; displacement of the engine/transmission assembly; and firewall deformation, thus retracting the throttle cable. Once throttle cable tension was released, the Throttle Plates of the Throttle Body firmly returned to the idle position.

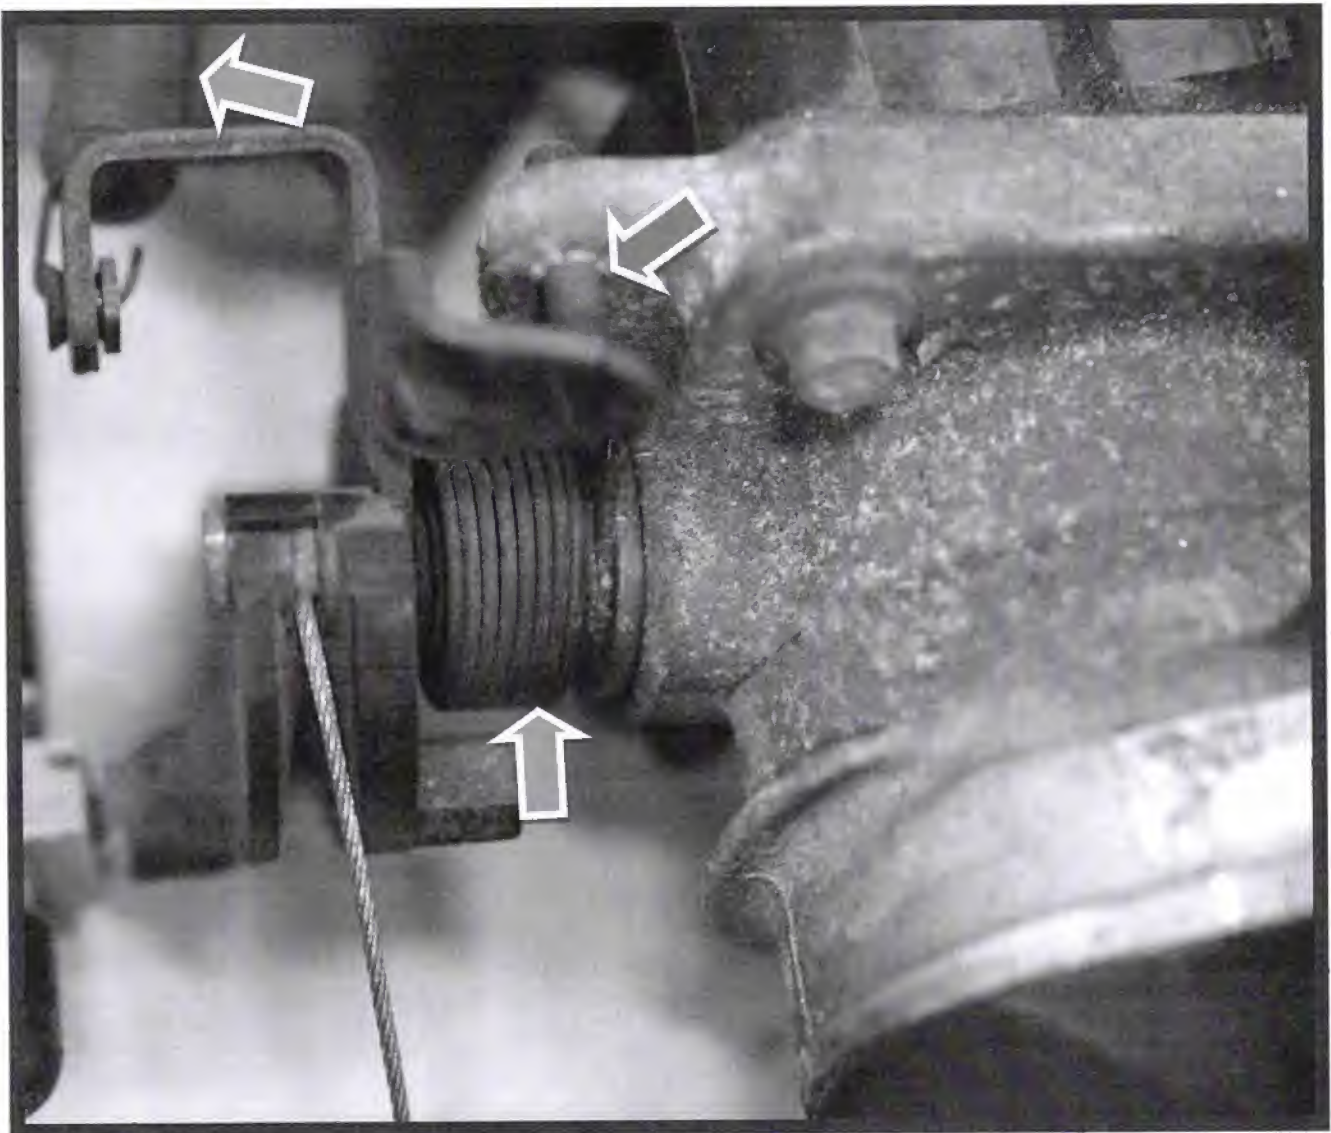
Image No.13. This photograph depicts the Throttle Body of the involved 2001 Ford Excursion stretch limousine during subsequent examination/analysis. The Blue Arrow denotes the Throttle Plate linkage, which is firmly at a position of closed Throttle Plates. No binding of Throttle Plate transition was present. The Orange Arrows denote the multiple intact and functional Throttle Plate Return Springs, mandated by applicable Federal Motor Vehicle Safety Standards. Digital Force Gauge testing revealed positive spring return to idle force of 7.733 lbs.

The pre-removal examination of the Throttle Body components also revealed that of a considerable engine vacuum leak present at a vacuum hose location. The noted condition of the source of the vacuum leak was consistent with that of a pre-existing condition.

The pre-existing condition of the vacuum leak at the Throttle Body would have resulted in an obvious deterioration of engine operational quality, especially during idle conditions. This condition certainly falls within the realm of proper vehicle maintenance, and the neglect thereof.

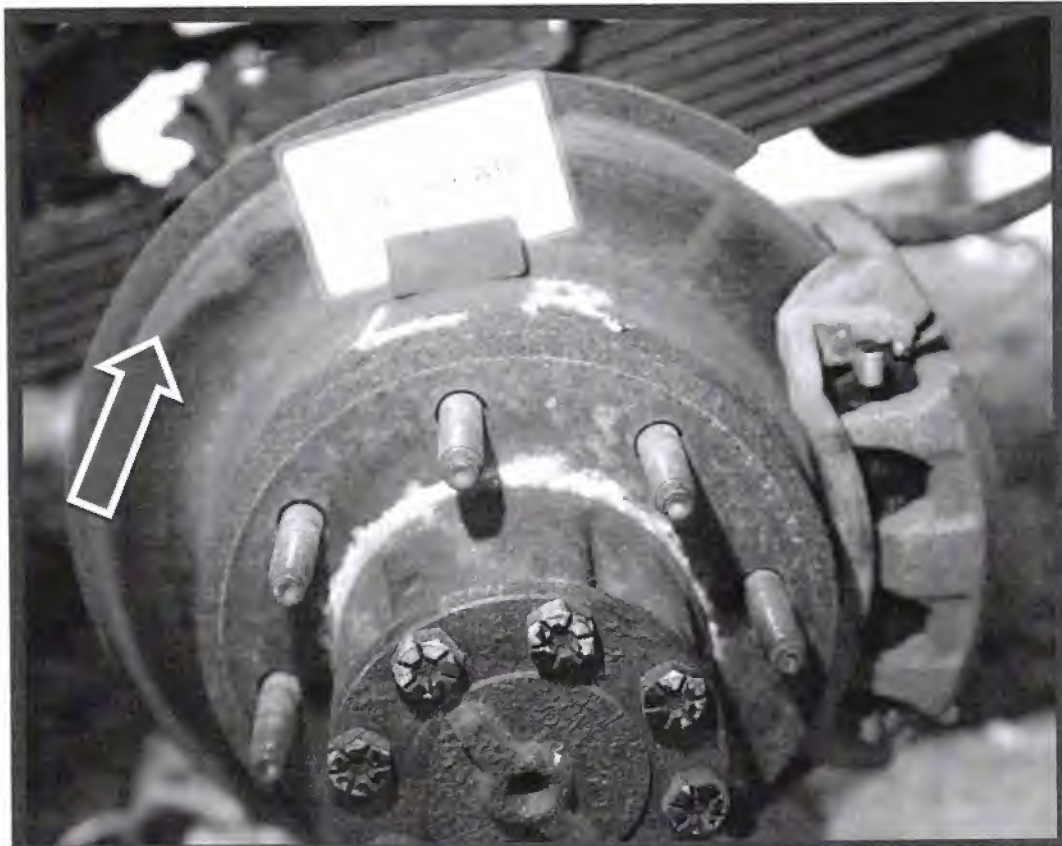
Image No.14. This photograph depicts the left rear disc brake components of the involved 2001 Ford Excursion stretch limousine prior to removal from the vehicle. Note the outer disc brake rotor swept area corrosion, which was a pre-existing condition (Red Arrow).

Disc Brake Caliper, Left Rear – The left rear disc brake caliper of the 2001 Ford Excursion stretch limousine exhibited slight casting oxidation, with both piston surfaces presenting insignificant exposure. This condition was consistent with the Repair Order of Mavis Discount Tire dated May 11, 2018¹¹, which indicated replacement of the Brake Caliper, Brake Hose, and Brake Pads. Brake dust presence was nearly nonexistent.

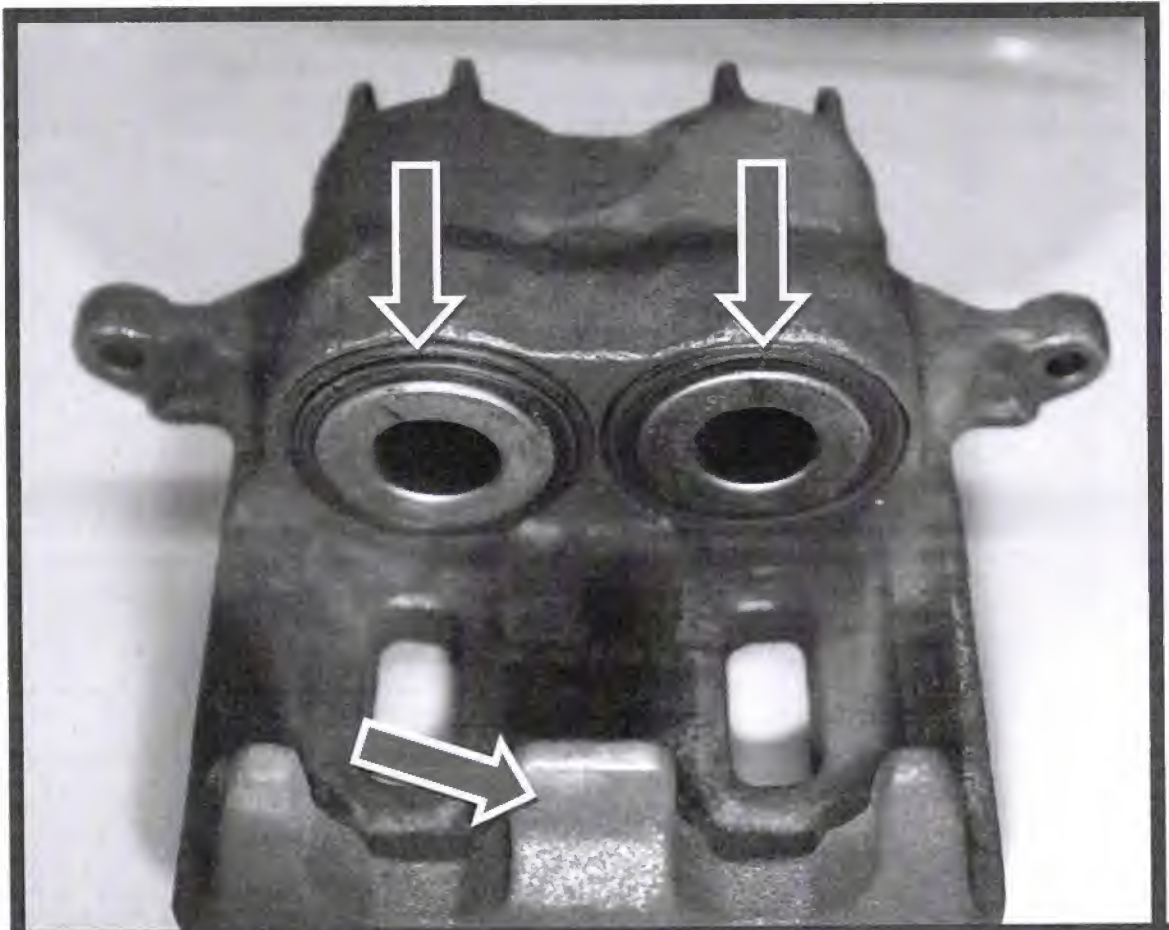
Image No.15. This photograph depicts the left rear disc brake caliper of the involved 2001 Ford Excursion stretch limousine during the period of individual component analysis. Note the state of the cast caliper body, as well as that of the two caliper pistons and piston seals (Blue Arrows). The condition of the component was consistent with that of replacement per the Repair Order of Mavis Discount Tire, dated May 11, 2018.

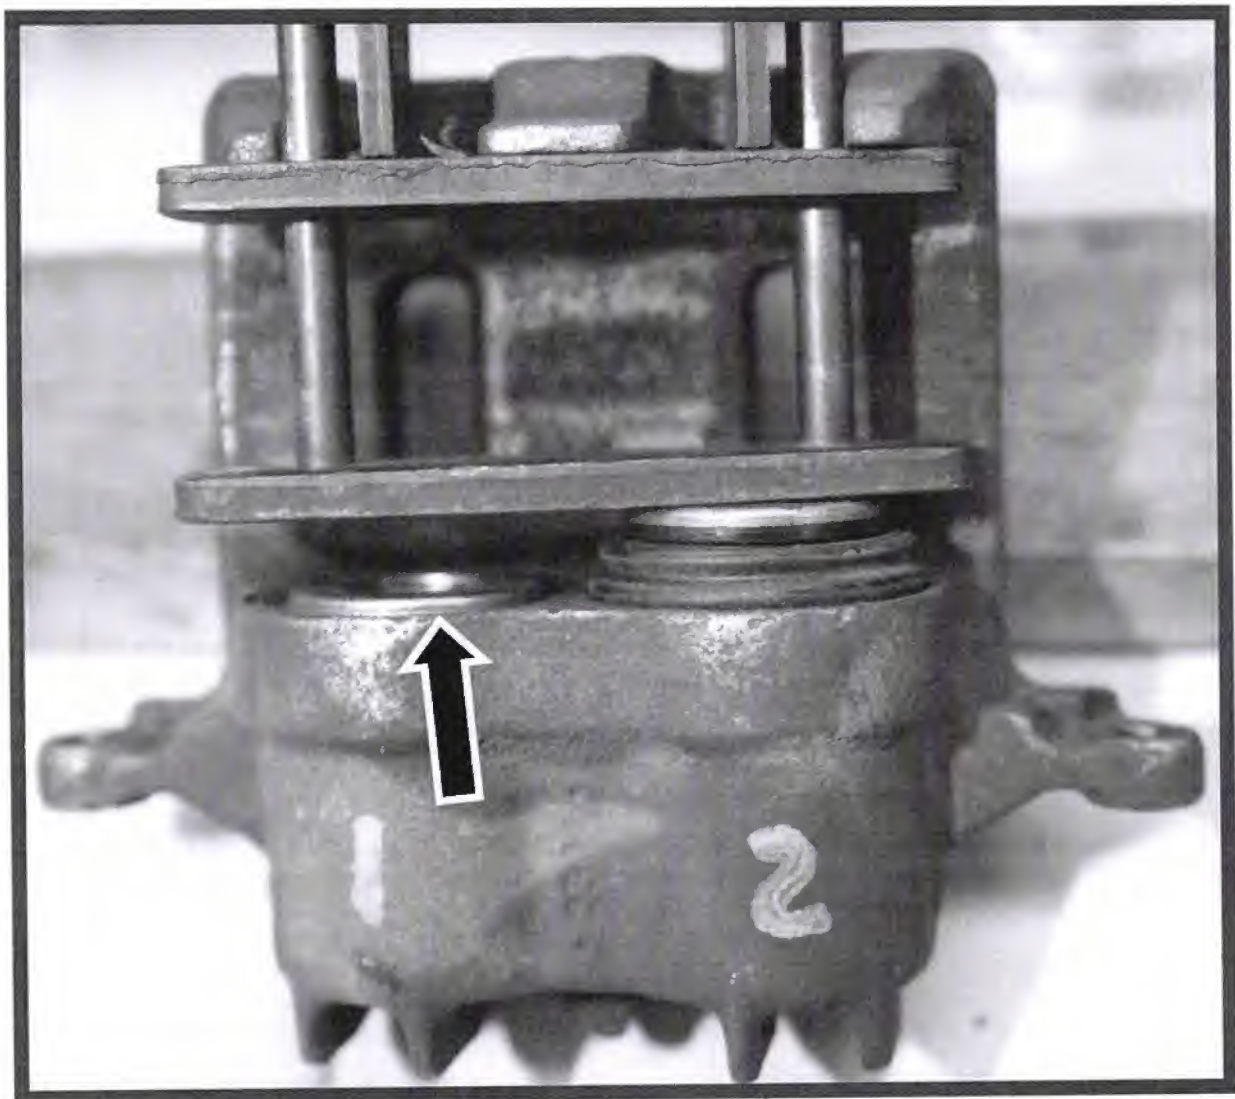
Image No.16. This photograph further depicts the left rear disc brake caliper of the involved 2001 Ford Excursion stretch limousine during the period of individual component analysis. Disassembly procedures revealed that the leading disc brake caliper phenolic piston, designated as Number "1", exhibited binding/partial seizure within its bore, noted within the image by comparing the height of the two pistons in the caliper housing (Black Arrow). This condition would result in reduced brake force at the left rear wheel location of the vehicle during stopping maneuvers.

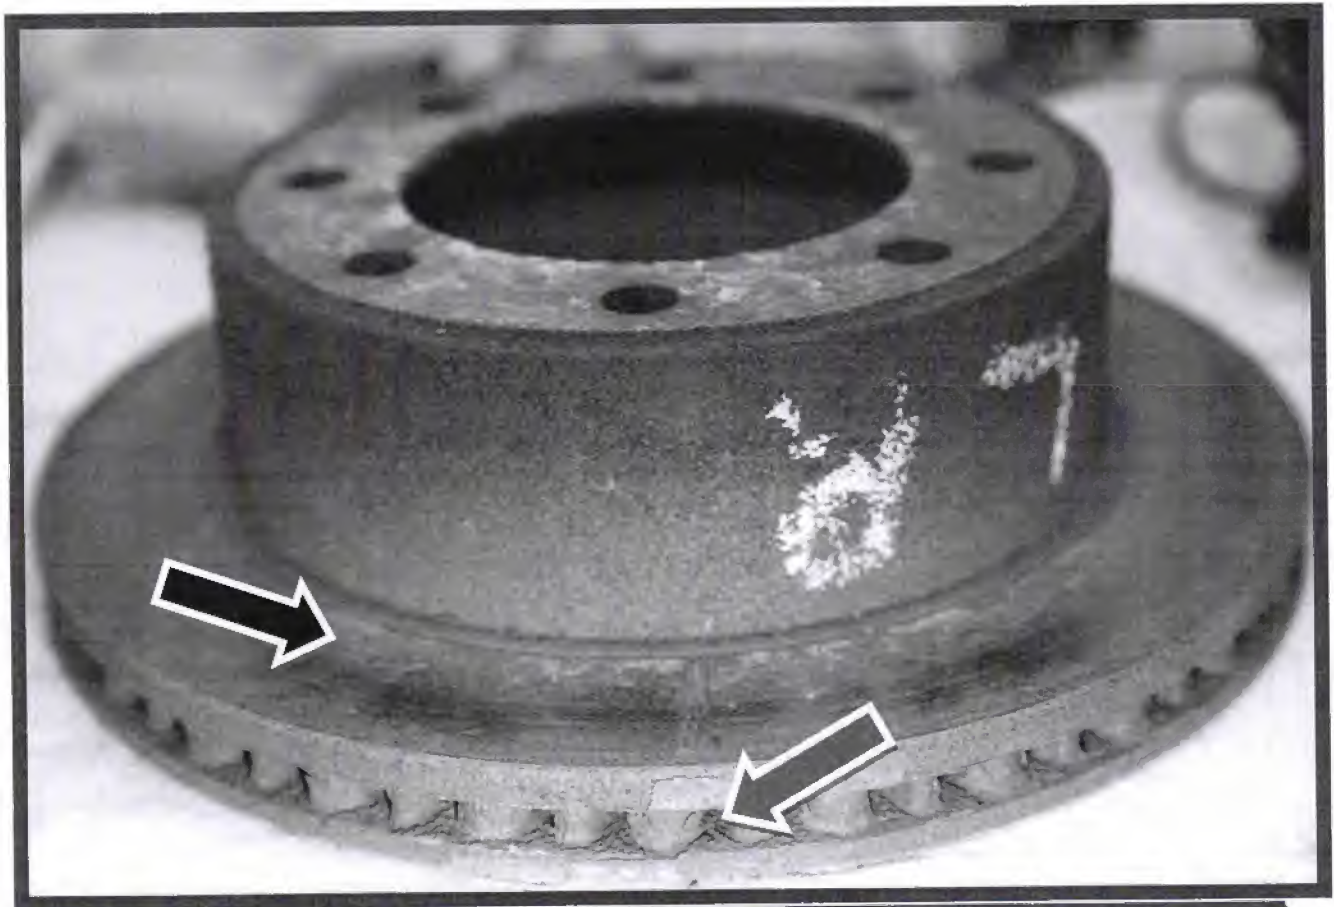
brake rotor of the 2001 Ford Excursion stretch limousine revealed that of a heavy duty, eight (8) stud hole, cast disc brake rotor. The left rear disc brake rotor is that of vented rotor design, with the friction surfaces consisting of an inner swept area surface, an outer swept area surface, and vanes located between the two surfaces which create air flow for brake system cooling. The examination of the left rear disc brake rotor of the 2001 Ford Excursion stretch limousine revealed heavy corrosion/scaling at the vane areas, resulting in a decrease of the brake system cooling design.

- ✓ No thermal distress noted.
- ✓ Minimal brake dust presence.
- ✓ Outer swept area exhibited corrosion, oxidation, pitting, and scoring.
- ✓ Inner swept area exhibited prominent scoring/excessive wear and delamination, consistent with continual prior metal-to-metal disc brake pad contact from neglect of brake system maintenance; additionally, inner swept area exhibited prevalent corrosion consistent with prolonged absence of braking effort at left rear wheel location.
- ✓ Disc brake rotor was not machined/replaced during brake service conducted by Mavis Discount Tire on May 11, 2018.
- ✓ Minimum measured left rear disc brake rotor thickness = 1.124". Original disc brake rotor thickness = 1.185". Minimum disc brake rotor thickness specification = 1.10". Minimum disc brake rotor thickness to machine rotor specification = 1.12".

Image No.17. This photograph depicts the left rear disc brake rotor of the involved 2001 Ford Excursion stretch limousine during the period of individual component analysis. Note the heavy corrosion/scaling (Red Arrow) present at the vent vane areas, resulting in a reduction in the effectiveness of the disc brake rotor cooling design. Also note the presence of corrosion at the outer swept area (Black Arrow) -- the area of contact by the outer disc brake pad friction material.

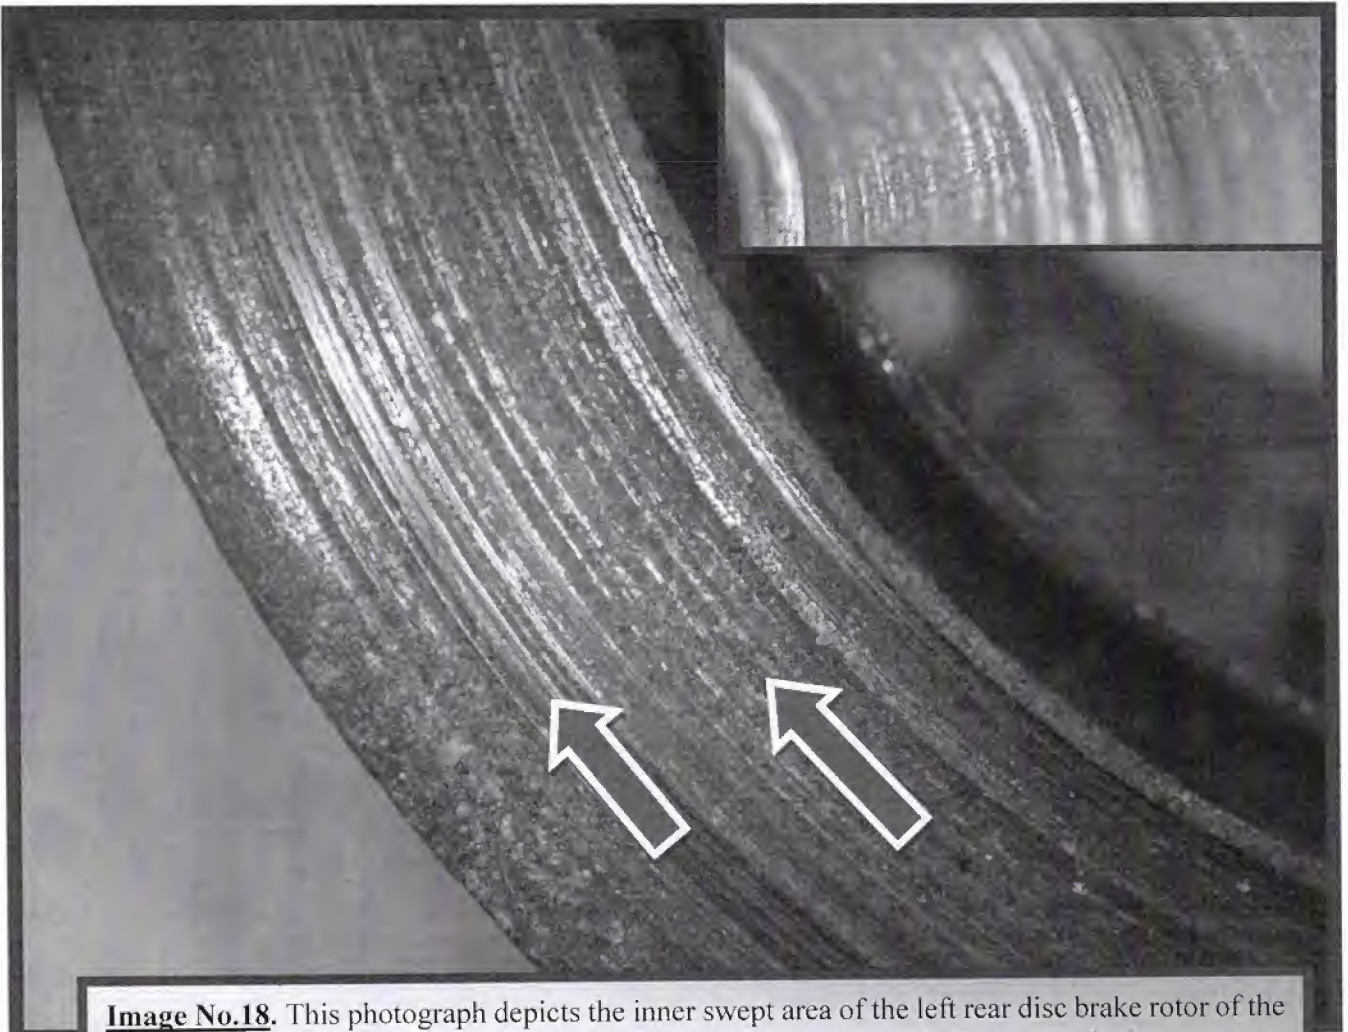
Image No.18. This photograph depicts the inner swept area of the left rear disc brake rotor of the involved 2001 Ford Excursion stretch limousine during the period of individual component analysis. Note the heavy corrosion/scaling and prominent scoring (grooving) present (Red Arrows), consistent with 1)the prolonged operation of vehicle with grossly deteriorated inner brake pad friction material; and 2)ineffective brake effort. Insert photograph depicts the extent of the corrosion/scoring. Photograph below denotes comparison of rotor thickness to that of new rotor.

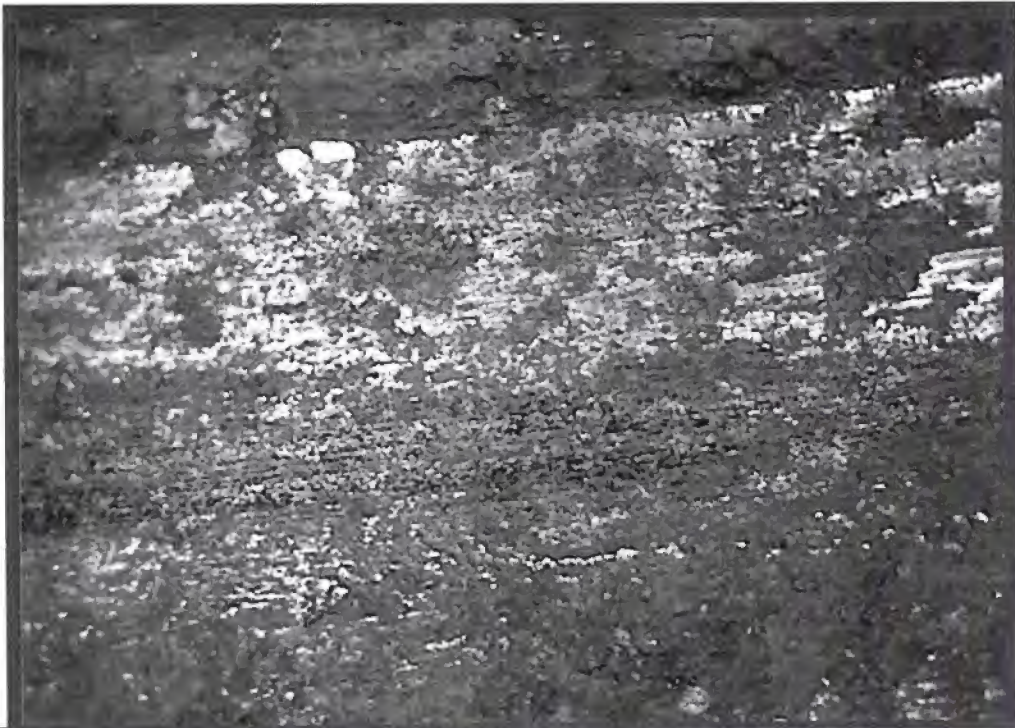
Images No.19a & 19b. These digital microscope photographs depict the critical state of corrosion/delamination present at the inner swept area of the left rear disc brake rotor of the involved 2001 Ford Excursion stretch limousine (above photograph), as well as the oxidation/corrosion present at the outer disk brake rotor swept area (bottom photograph).

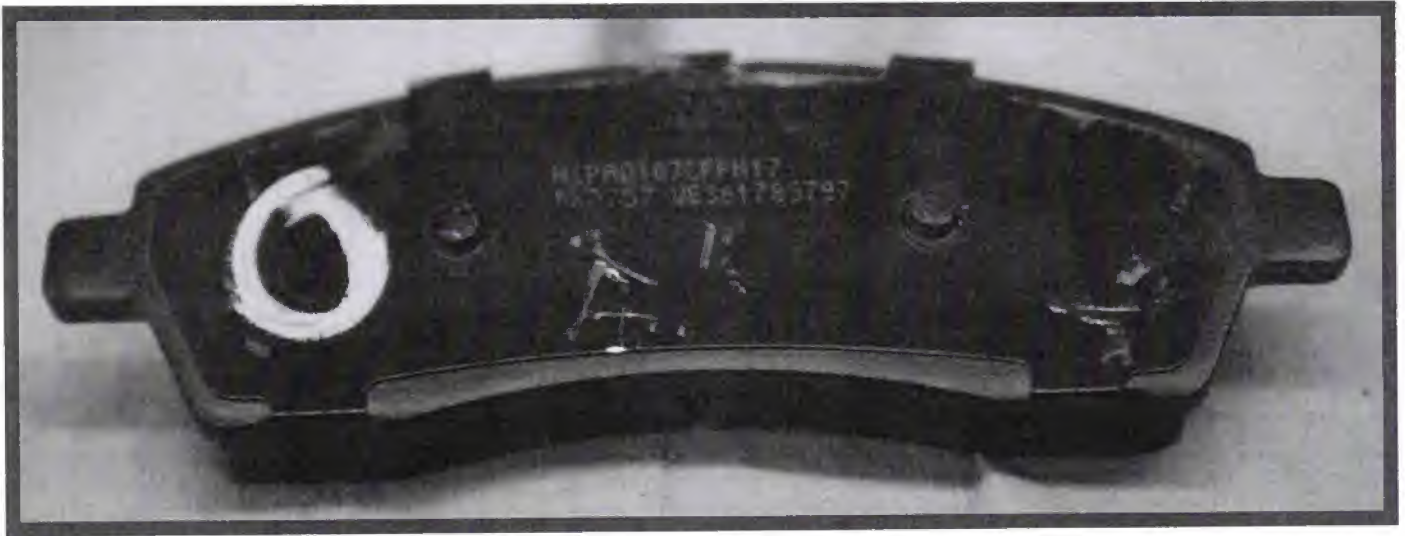
- ✓ Digital measurements of friction material thicknesses of inner and outer disc brake pads exhibited minimal discrepancies compared to digital measurements of new disc brake pads purchased for comparison, despite replacement by Mavis Discount Tire on May 11, 2018.
- ✓ Bonded design disc brake pads, semi-metallic composition.
- ✓ Brake dust presence nearly nonexistent.
- ✓ No thermal distress noted.
- ✓ Original black steel foundation plate paint clearly evident.
- ✓ Inner disc brake pad friction material exhibited embedded corrosion deposits, with no evidence of scoring wear from severely scored inner left rear disc brake rotor swept area.

Images No.20a & 20b. These photographs depict the outer disc brake pad (above photograph) and inner disc brake pad (bottom photograph) of the involved 2001 Ford Excursion stretch limousine. Note the obvious "as new" appearance inclusive of intact original black paint and absence of inner disc brake pad friction material striations resulting from brake force at scored inner disc brake rotor swept area.
